# TOPOGRAPHIC AND GEOTECHNICAL FINAL REPORT FOR WESCO PLANT- KISMAYO DISTRICT, LOWER JUBBA REGION, JUBBALAND STATE- SOMALIA

*Client: Waamo Energy Service Compony (WESCO)*

*JUNE 2024*

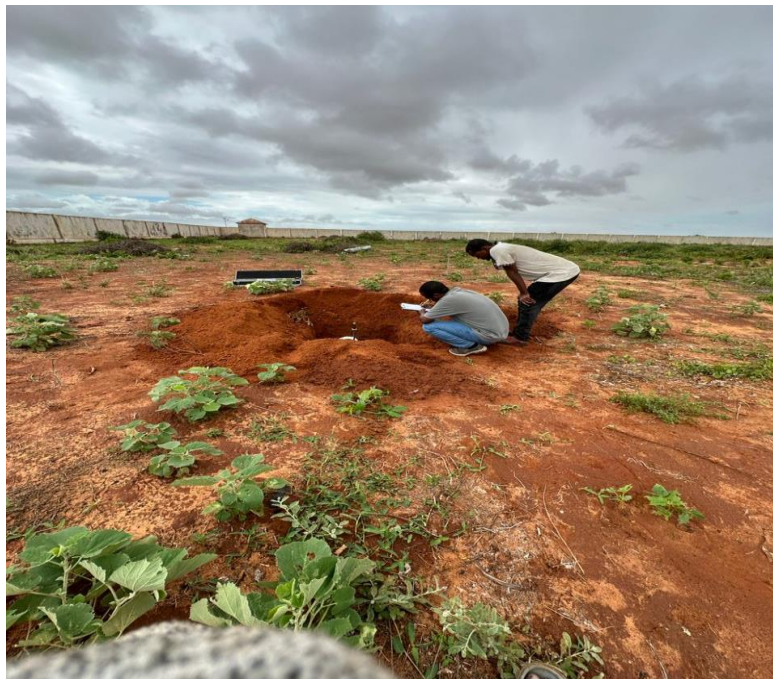
*Figure 4: Soil Samplin*

The side was selected randomly from 10 trail pits as you can see the image below.
